Manhole Inspection Summary

Manhole # S47CC_017MH

Insp Date: **2/4/08 12:35 PM**

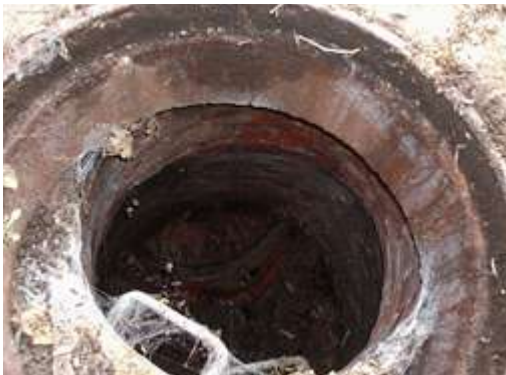
Defect 2

Frame Offset: **2** (in.)

offset frame

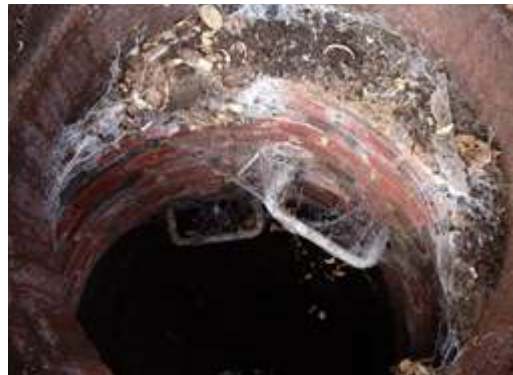
Defect 1

☒ **Leaks**

Frame leaks

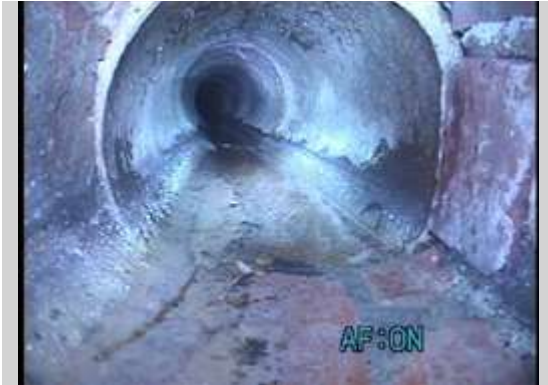
12 O'Clock Outflow

10 in. Circular Gravity Sewer
Pipe Out @ 12 O'Clock

Pipe Height: **8.4** (in.) Rod and Bar (Angled)
Pipe Material: **Clay** ☐ Pipe Lined
Invert Depth: **8.60** (ft.) Flow Characteristics: **Slow**
Deposits: ☒ None ☐ Mud ☐ Sludge ☐ Debris ☐ Grease
Silt Depth: (in.) Deposits Extent:
Infiltration: **None** Pipe Seal Cond: **Sound**

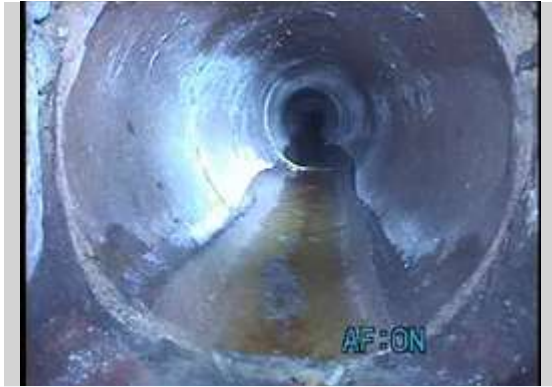
9 O'Clock Inflow

Pipe In @ 9 O'Clock

Infiltration: **None** Pipe Seal Cond: **Sound**
